This was no accident

-- the death of an Otis contract worker and the responsibility of the Otis management

March 15, 1999: At around 10.00 a.m. in Worli, Bombay, a contract worker, Asad Khan, is gravely injured in an accident during the course of working at a lift modernisation site. After the accident, he is taken to K.E.M. Hospital, where he dies by 2.00 p.m.

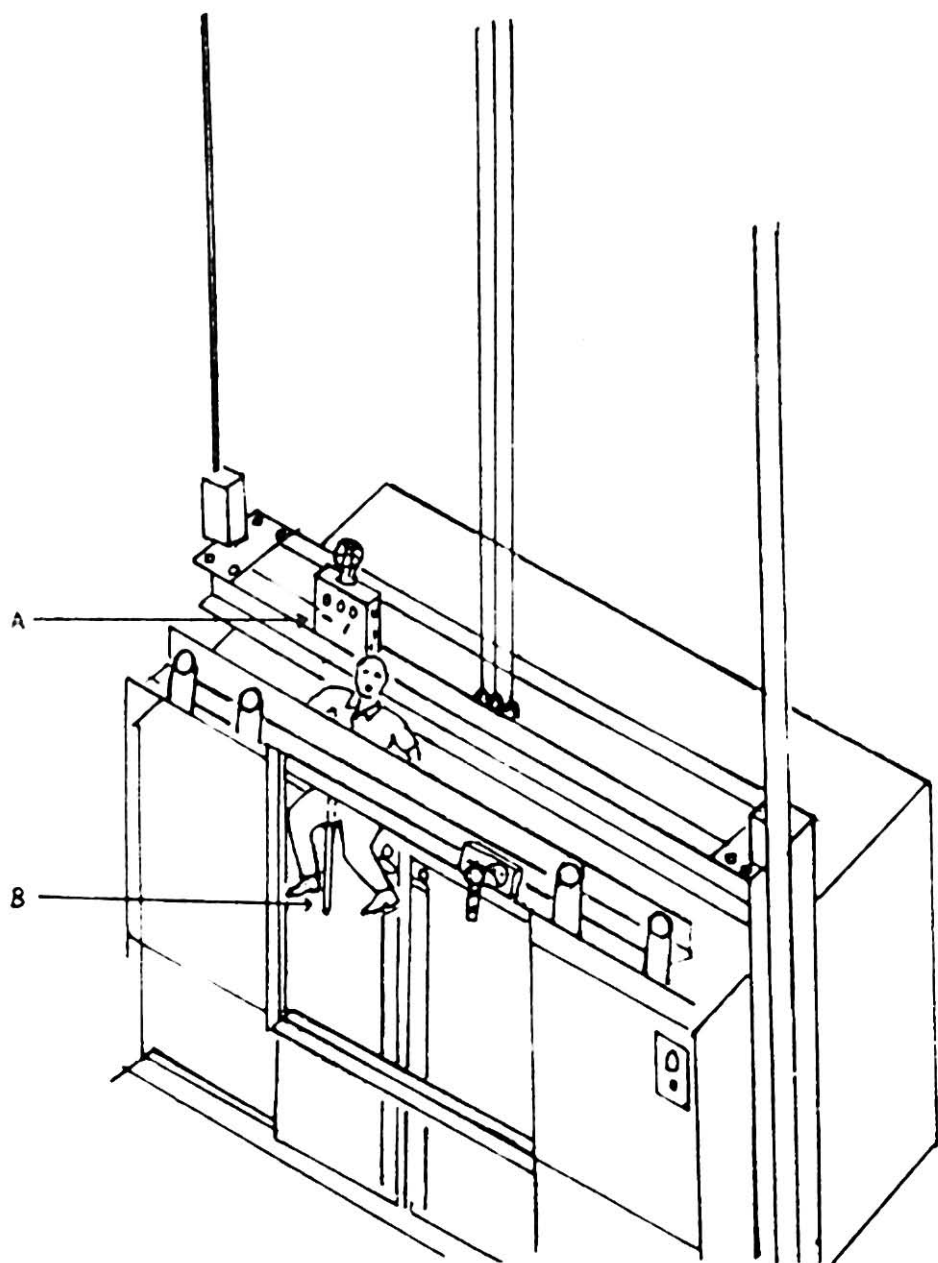
A visualisation of the incident as it would appear if the walls were transparent
The object 'A' is the TOCI box 'B' is the spear cam, shown entering the body

In order to understand the management's analysis of the "root cause of the accident", we need a brief picture of the situation. On the roof of the lift, attached to the crosshead, there is a box with "top of car inspection" (TOCI) buttons and switches. These face the front of the lift. Standing on top of the lift, an employee can use these controls to run the lift up and down. One is the Stop switch, which has two settings, Stop and Run. When the switch is on Stop, the lift will not move. A second switch has two settings, Inspection and Normal. When the switch is on Inspection, the lift will move only at inspection speed, ie at one-fourth of normal speed. Apart from these, there are switches to run the lift up and down.

though he did not know this. Since the space on the roof was small, Asad stood at the front of the lift (ie, in front of the crosshead — the section closer to the door). While facing in the direction of the door, he operated the TOCI controls behind his back. Since he could not see the controls, he accidentally operated the wrong switch: he thought he was turning "Stop" to "Run", whereas he in fact was turning the Inspection switch to Normal position.

The technology used in this lift (NE300 controller) has a mechanism whereby, if the lift is not in Inspection mode and is not at door level, it automatically corrects itself by going either up or down to the next level. This is to ensure it does not get stuck between floors. (However, if the lift is Inspection mode, ie, when work is being carried out on the lift, it will not "correct" itself by going up or down.) Thus when Asad turned the Inspection switch to the Normal position, and (unknown to him) the Stop switch was already in the Run position, the lift behaved as a normal running lift should when it is between two floors — that is, it went into a "correction" by automatically moving up toward the first floor *at the normal speed* of one metre per second. This resulted in Asad's losing his balance and falling forward on the spear cam rod.
